FLOOD PLAIN INFORMATION

LEY CREEK

SALINA AND DEWITT

CORPS OF ENGINEERS, U.S. ARMY
BUFFALO DISTRICT

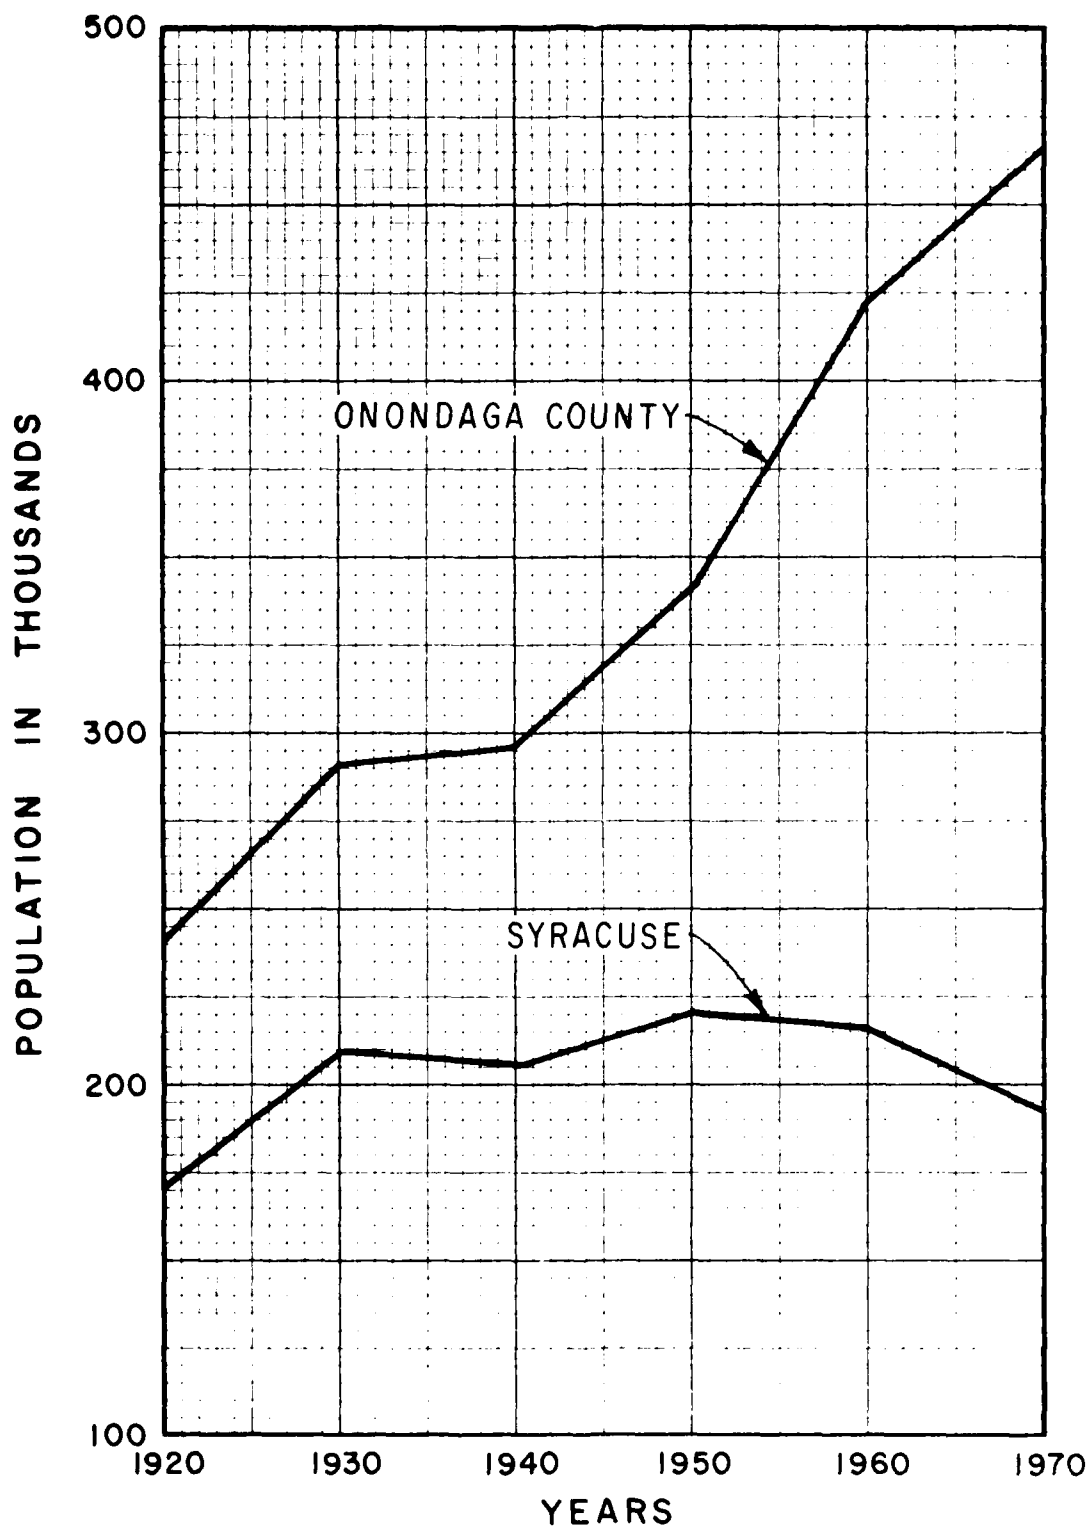
FIGURE 1

POPULATION TRENDS

POPULATION - The U. S. Bureau of Census indicated that, between 1960 and 1970, the population of the city of Syracuse decreased from 216,038 to 192,529, a drop of 11 percent in 10 years. During the same period, the population of Onondaga County increased from 423,028 to 466,334, an increase of 10 percent. Figure 1 shows graphically the population trends of Syracuse and Onondaga County.

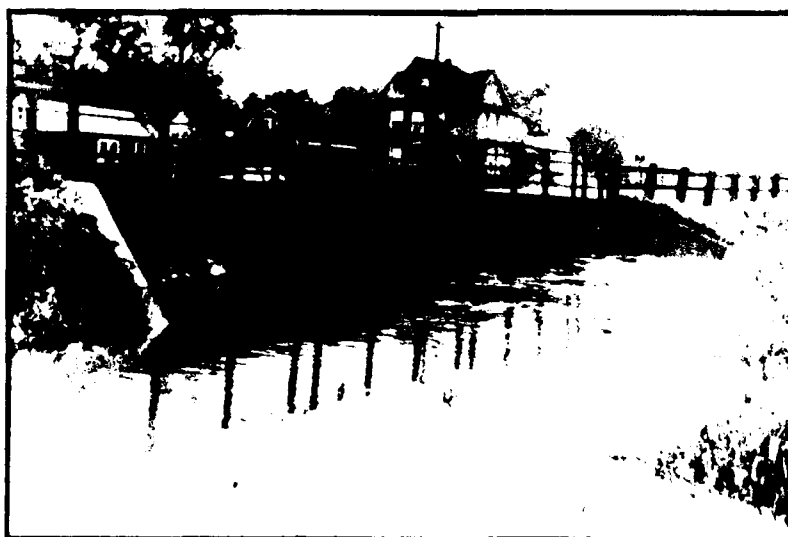
Figure 9 - View of Lemoyne Avenue bridge, stream mile 2.17. Debris cannot pass under the bridge during high flows.

BRIDGES ACROSS THE STREAM - There are seven highway bridges and two railroad bridges which cross Ley Creek within the study area. Table 2 lists pertinent data for these structures and shows their relationship with the Standard Project and Intermediate Regional Floods. Inspection of the flood profiles on plate 4 shows that several of the structures are constrictive and cause large head losses (defined in Glossary). The high level bridge at Interstate Route 81 has very little hydraulic effect on the stream profile; therefore, it was not shown on plate 4 or table 2. The profiles on plate 4 should be used as a guide for all future construction of new bridges or alterations to existing bridges which cross the Creek in the study area. Views of some of the bridges are shown in figures 6 through 11.

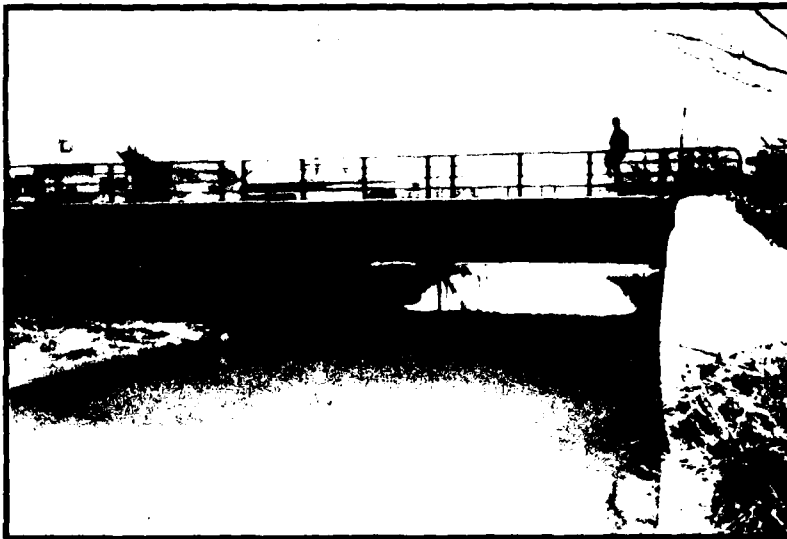
Figure 10 - Looking at the upstream side of Lemoyne Avenue bridge, stream mile 2.17. Note shoaling along left side of channel.

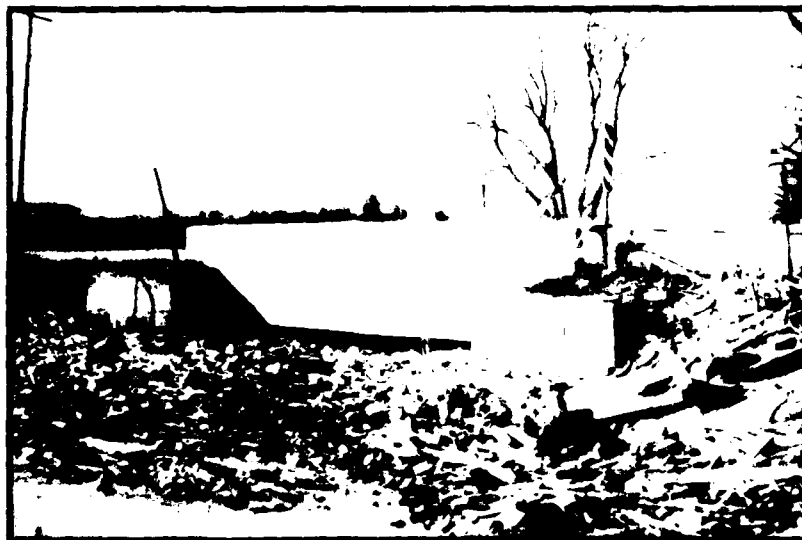
Figure 13 - Looking at the upstream side of 7th North Street bridge, where the channel has become choked with debris, stream mile 1.17.

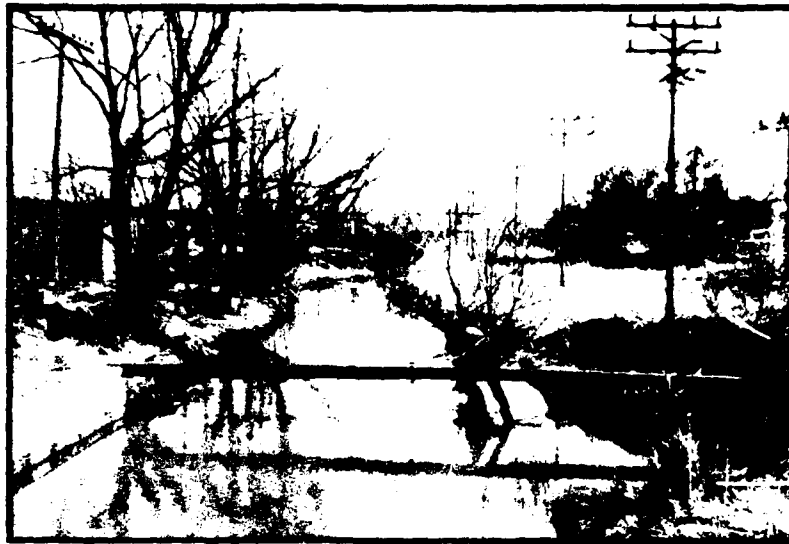
Figure 14 - Photo of pipeline across the creek just upstream from Lemoyne Avenue, stream mile 2.18.

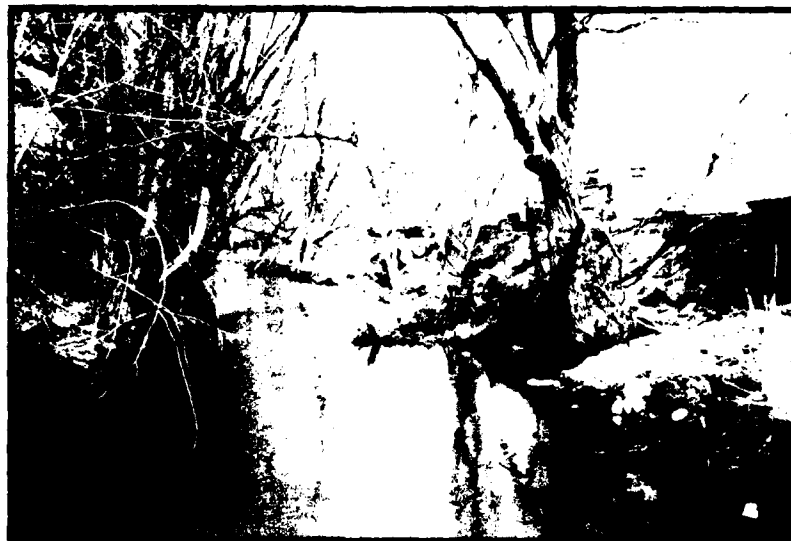
Figure 15 - Photo shows where channel banks have become overgrown with trees and brush near Factory Avenue, stream mile 2.30.

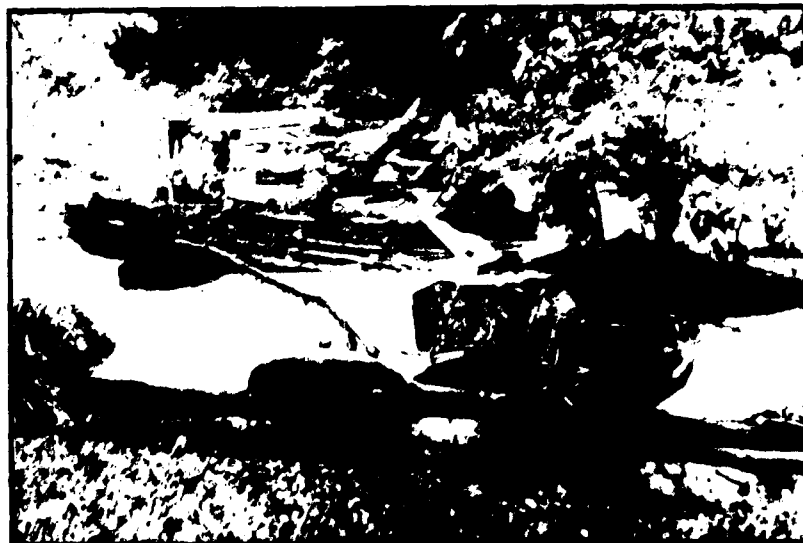
Figure 17 - Photo shows heavy build-up of debris in South Branch near Manlius Street bridge.

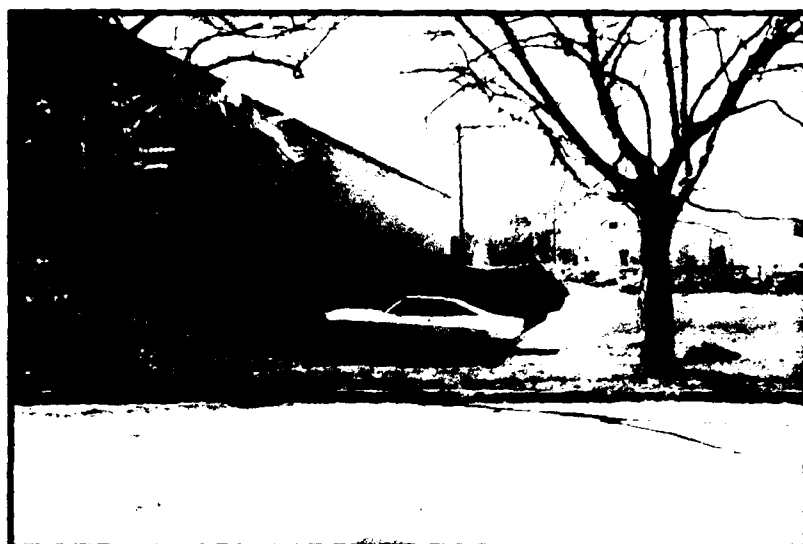
Figure 18 - Building at 2nd North Street and Hiawatha Boulevard which has been built at an elevation well above the Standard Project flood, stream mile 0.5.

By using the flooded area maps, flood profiles and cross sections contained in this report as a guide, local governments can pass regulations which limit urban and industrial development that will be allowed in the flood plain. Use of the flood plain for recreational development should be encouraged. In the future, additional recreational facilities of all types will be needed as the population increases. The placement of these additional parks, athletic fields, possible golf courses, drive-in theaters and similar developments in those areas which are susceptible to frequent flooding is recommended because of their important value and relatively small flood damage potential. If future high value development is considered in areas subject to frequent flooding it should be raised above the 100-year flood level. If it is found uneconomical to elevate the land in these areas, means of flood proofing the structure should be incorporated. Figures 18 and 19 are pictures of examples of wise flood plain use.

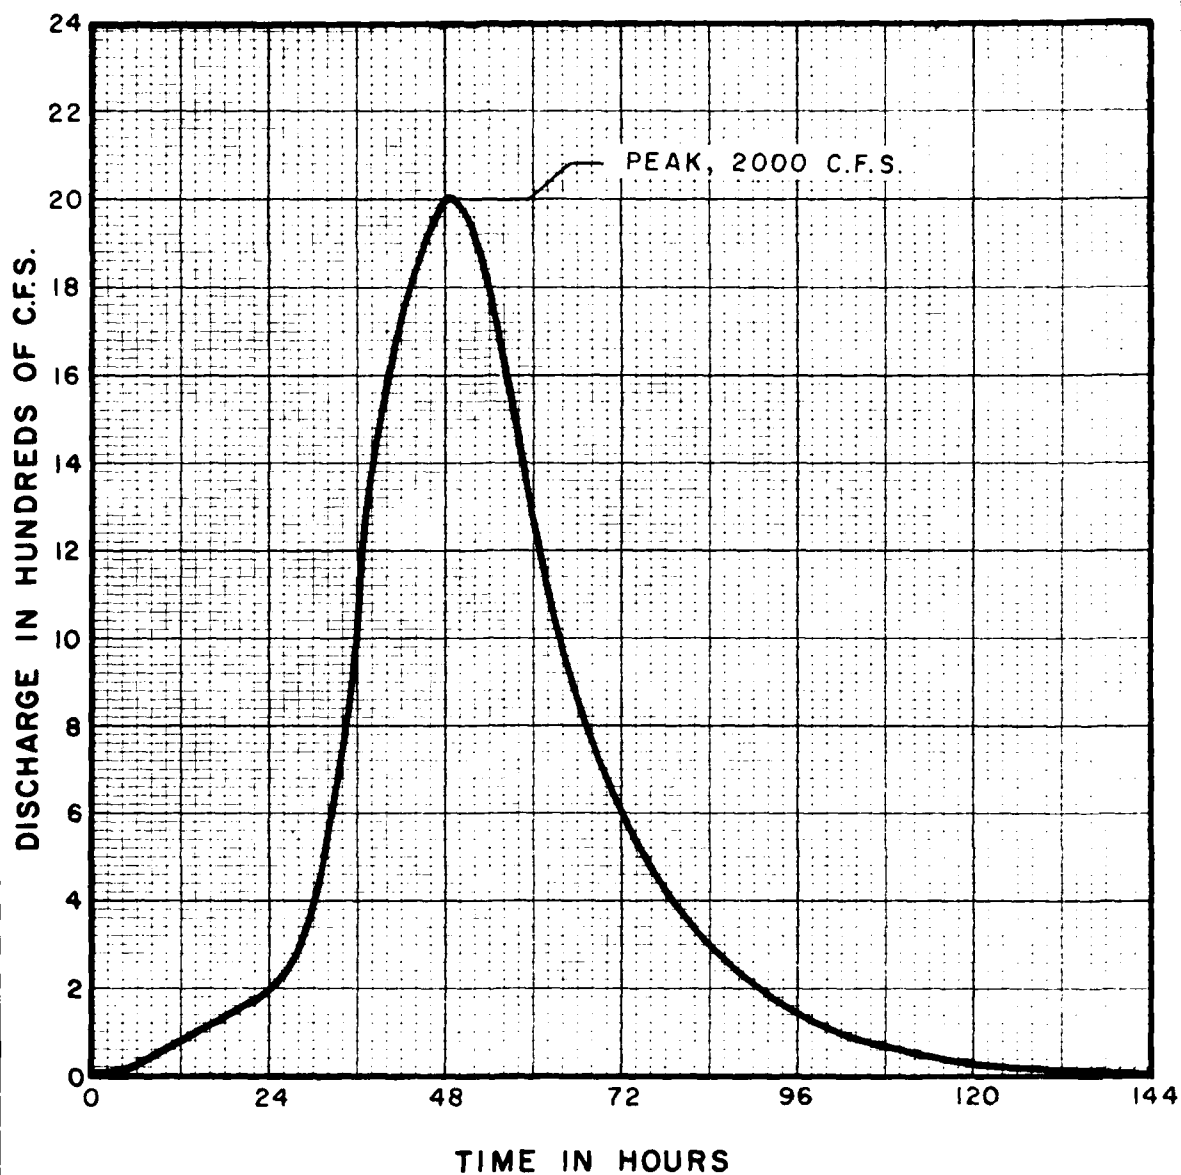
Hydrograph estimated by the
Corps of Engineers.

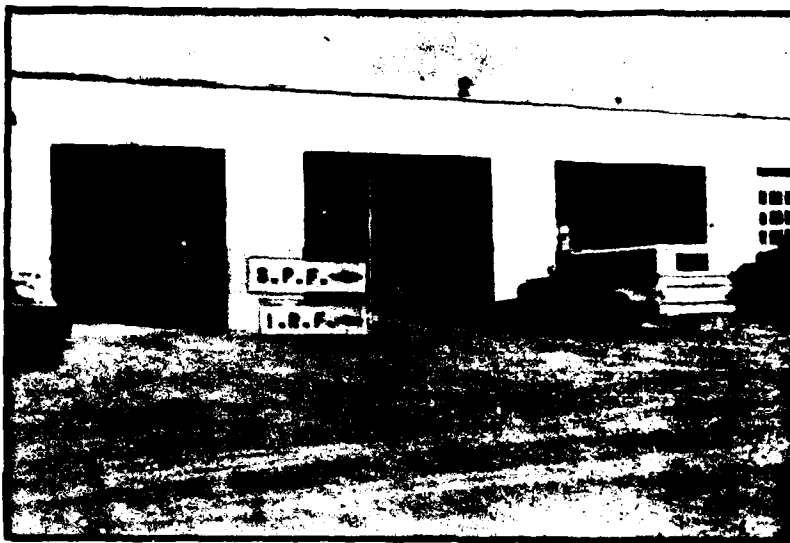
Figure 33 - Arrows indicate the heights of the Standard Project and Intermediate Regional floods at Central New York Freightways Garage on 6th Street, stream mile 0.99.

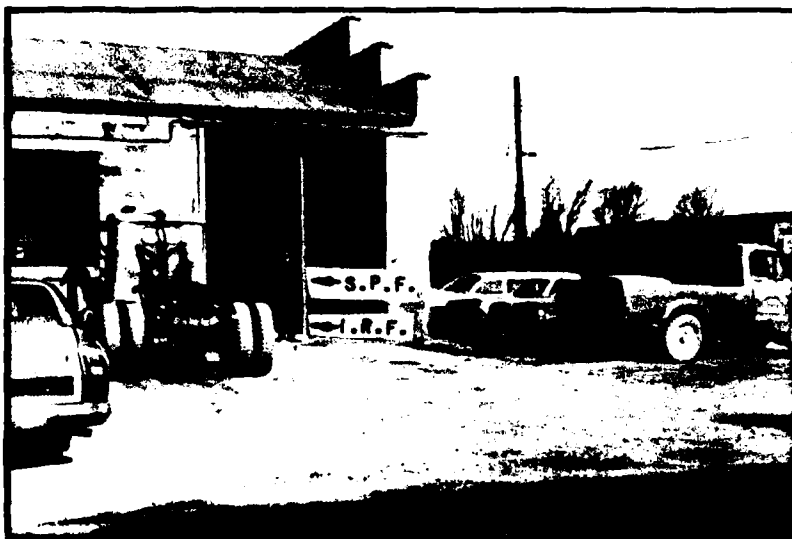
Figure 34 - Arrows indicate the heights of the Standard Project and Intermediate Regional floods at the Tuffy Trucking Garage on 6th North Street, stream mile 0.99.

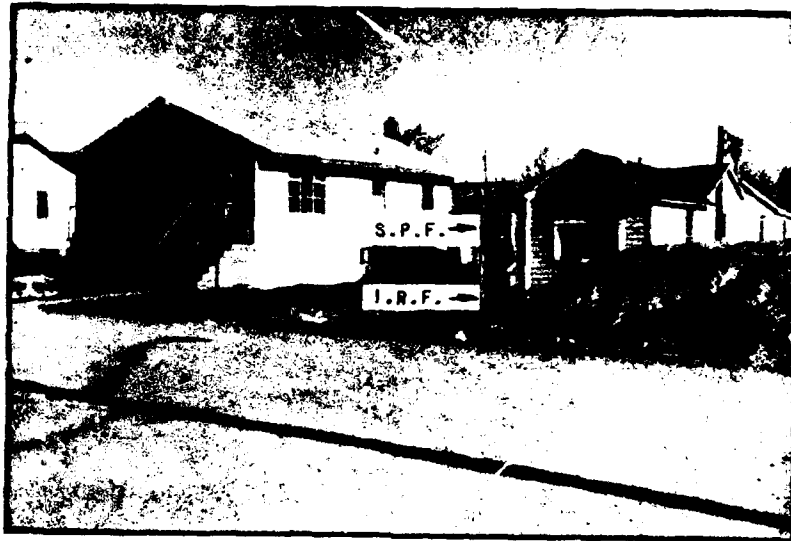
Figure 35 - Arrows indicate the heights of the Standard Project and Intermediate Regional floods on Cambridge Avenue, stream mile 2.50.

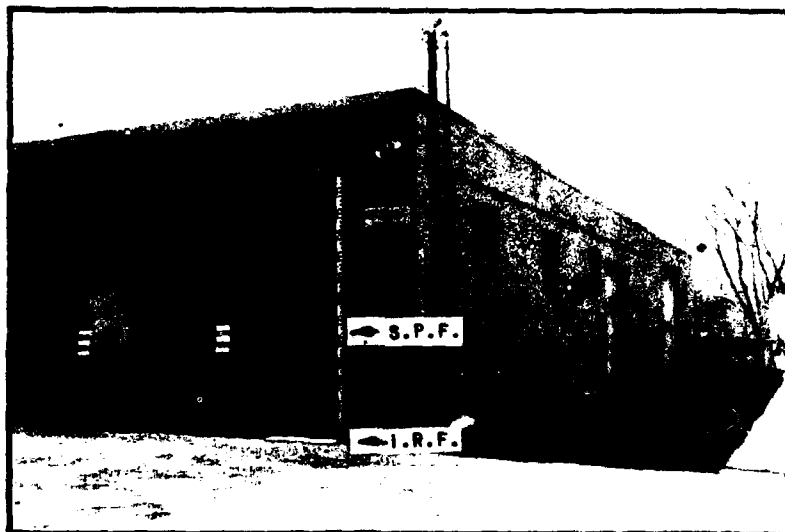
Figure 36 - Arrows indicate the heights of the Standard Project and Intermediate Regional floods at Bomac Inc. on Cambridge Avenue, stream mile 2.40.

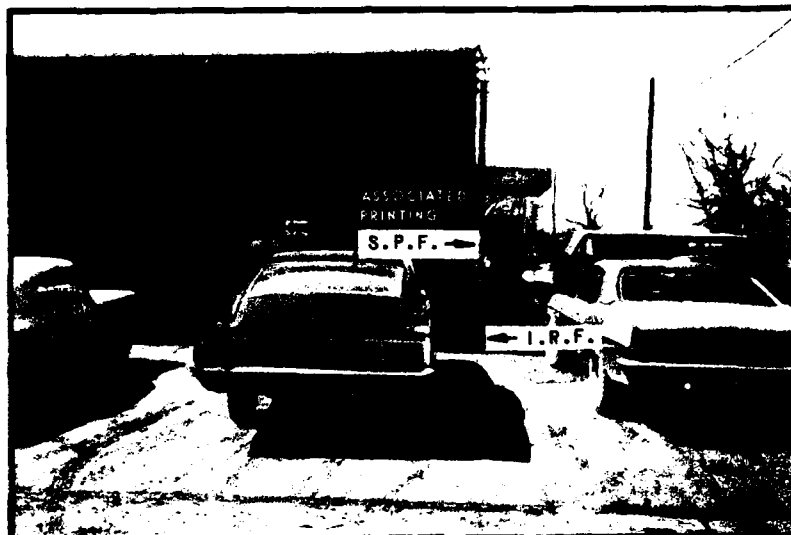
Figure 37 - Arrows indicate the heights of the Standard Project and Intermediate Regional floods at Associated Printing Service on Cambridge and Mitchell Avenues, stream mile 2.45.

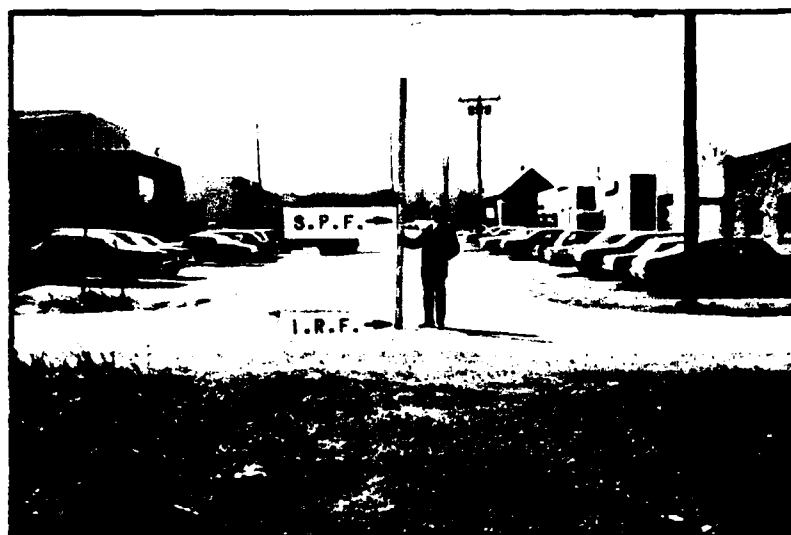
Figure 38 - Arrows indicate the heights of the Standard Project and Intermediate Regional floods at the intersection of Mitchell and Cambridge Avenues, stream mile 2.45.
